YOUR ONESURVEY
HOME REPORT

Flat 2/6 - Flat (25)
112 Cowcaddens Road
Cowcaddens
Glasgow, G4 0HL

SINGLE SURVEY

Single Survey

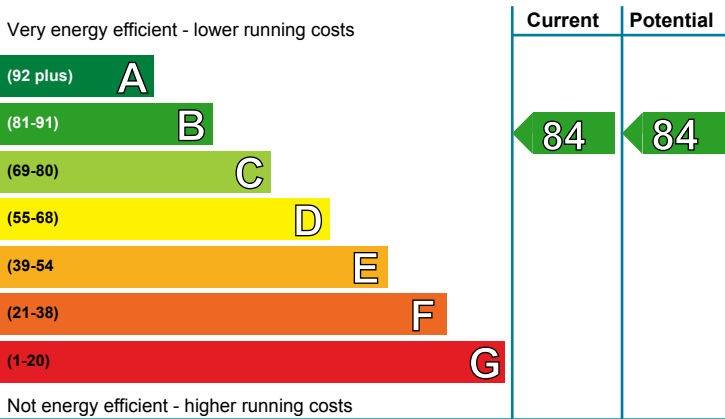
Energy Efficiency Rating

This graph shows the current efficiency of your home, taking into account both energy efficiency and fuel costs. The higher this rating, the lower your fuel bills are likely to be.

Your current rating is **band B (84)**. The average rating for EPCs in Scotland is **band D (61)**.

The potential rating shows the effect of undertaking all of the improvement measures listed within your recommendations report.

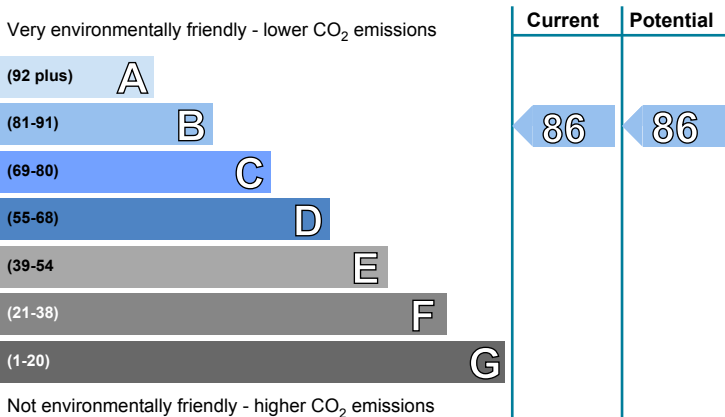
Environmental Impact (CO₂) Rating

This graph shows the effect of your home on the environment in terms of carbon dioxide (CO₂) emissions. The higher the rating, the less impact it has on the environment.
